Composites - A new look!

Dyed Pink Alabaster

Polymer - filled Tanzanite

GEM TESTING LABORATORY

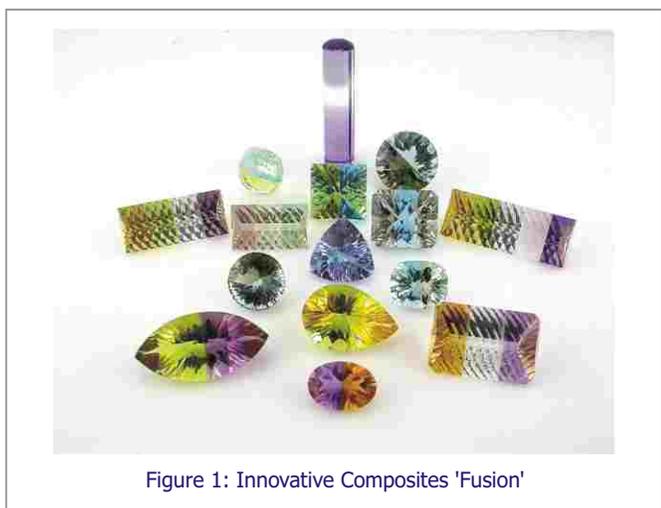
Figure 1: Innovative Composites 'Fusion'

For many decades 'composite' gem materials have been made to imitate well-known gem materials like emerald and corundum, to improve the overall appearance of a gem or to provide durability for a specific gem like opal. However, there are other instances when composites have been made to create fancy materials with their own eye-catching appeal as described in one of the articles, 'Innovative composites Fusion' (figure 1) published in the Gems & Jewellery (June 2008, volume 17, no. 2) magazine of the Gemmological Association of Great Britain, authored by Gagan Choudhary. The article described various combinations of commonly available gem materials such as citrines, amethysts, lemon quartz and topaz. This changed the concept of composites (see again, figure 1), which are usually made to imitate a well-

known gem material or to increase durability. For many years composites have been made using two or three materials joined together along or near the plane of the girdle to enhance the colour or durability, which was not the case in these composites.

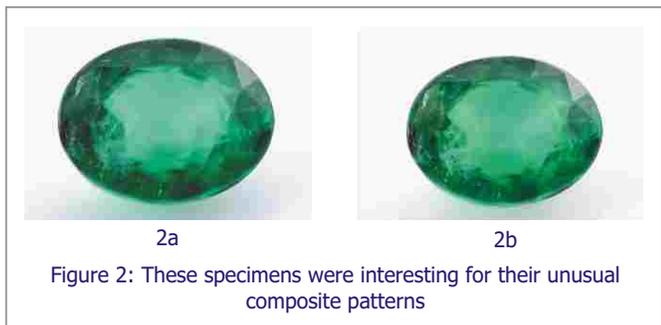
Figure 2: These specimens were interesting for their unusual composite patterns

Recently two green stones were submitted to the Gem Testing Laboratory Jaipur for identification within a period of one month, both of which proved to be composites. The two stones (figure 2.a & b) weighing 2.64 and 7.58 ct and measuring 9.93 x 7.62 x 5.50 mm and 13.66 x 10.76 x 7.45 mm respectively, warrant a description due to their interesting and unusual nature.

Preliminary observations indicated that the stones could be emerald on the basis of their colour (see again, figure 2). Both specimens were green of medium to high saturation with fairly good transparency, and a few scattered black inclusions along with 'feathers' and tubes were visible. These features were quite enough to identify the specimens as natural emeralds. But gemmology teaches us not to give a conclusive identification of a stone unless it has been analyzed thoroughly and hence we observed the stones under the microscope. The features we saw were shocking.

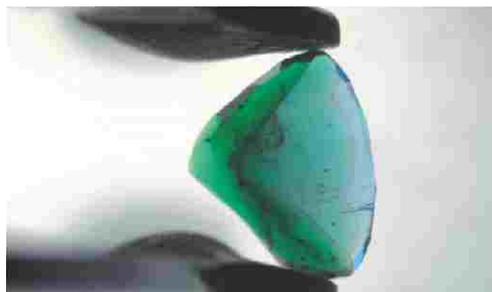
Figure 5: Deep green (glass) area towards the pavilion, while central area is pale green (beryl)

In addition, there were fine yellowish junctions between various layers (Figure 6) which could have been due to glue. The presence of such junction planes proved the stones to be composites. Magnification revealed that they were composed of a central pale coloured faceted material with smaller deeper green pieces glued to the pavilion areas.

The central near-colourless region and the pavilion areas displayed different inclusion patterns. Features such as crystals, tubes, blades, liquid 'fingerprints', generally associated with a natural stone, were observed in the central area, while gas bubbles could be seen in the pavilion. The inclusion features indicated the use of a pale coloured beryl in the centre surrounded by glass segments. However, further tests were conducted in order to identify conclusively the nature of materials used.

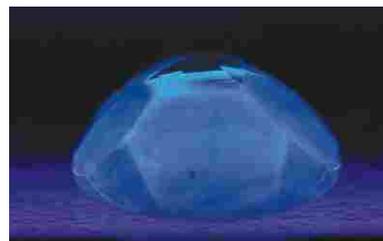
Figure 7: UV Fluorescence

with these stones; an eye-catching reaction was observed when the specimens were exposed to long- and short-wave UV light. A chalky bluish glow was displayed along the junction planes on the pavilion area (figure 7). This fluorescence effect, restricted to just below the pavilion surfaces, appeared to have been caused by glue.
